Challenging on-site construction issues

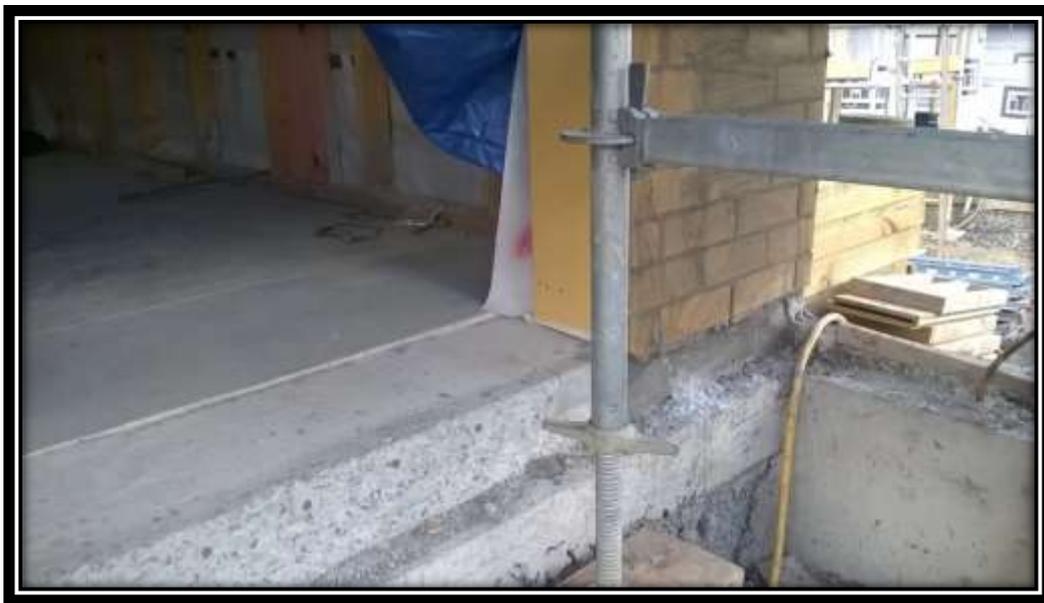
- The basics of concrete slab set outs and formwork do not meet the requirements of the building consent documents or the building code resulting in slabs being cut with concrete saws leaving reinforcing steel exposed or brackets added to support exterior wall framing. Brick cavities are too narrow or have been altered to try and correct the mistakes made at the slab set out. Foundation piles are out of alignment resulting in bearers failing to land on top of the pile within the specifications of NZS 3604.

Exposed reinforcing steel as a result of mistakes in the slab set out

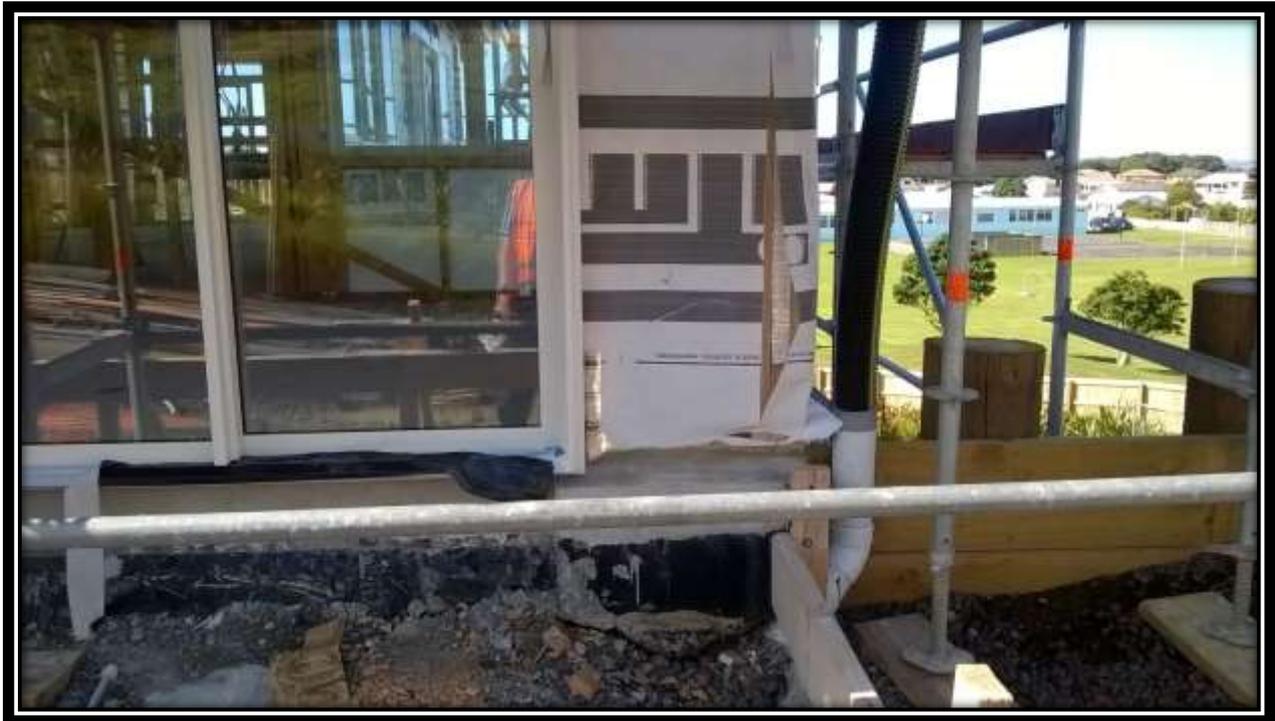
- Building wraps are not installed to the manufacturer's specifications resulting in loose installation or failing to finish at the correct height at the base of the external framing causing issues when the bricklayer starts laying the brick veneer or any other cladding is installed. The installation of the selected insulation product will then cause the un-tensioned building wrap to bulge into the brick cavity causing wicking to the timber framing. Joints between multiple claddings are often not flashed correctly or not flashed at all; these are critical areas of moisture ingress to the timber framing

Poorly installed building wrap

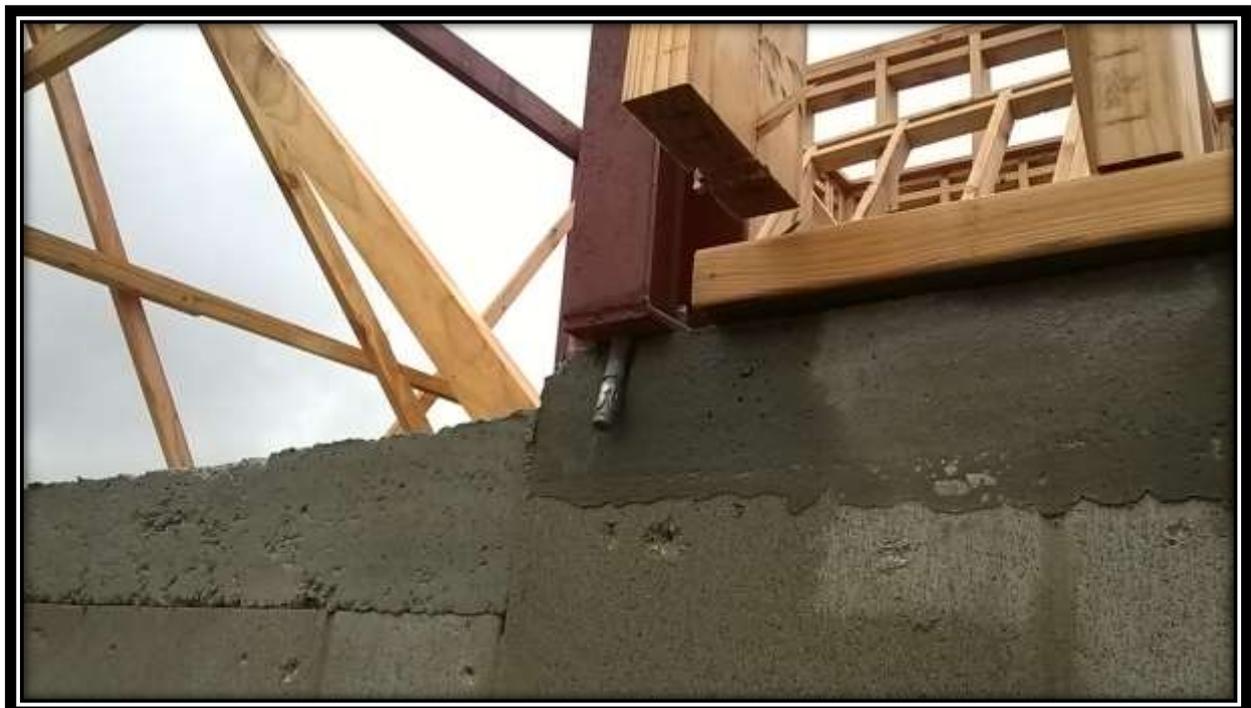
- Framing is incorrectly fixed down and on occasion the framing has been erected overhanging the exterior block work, resulting in minimal support and connection to the floor slab. In these instances, the slab fixing has no value for hold down purposes or bracing requirements. This also results in minimal support to wall framing and the transfer of roof load paths to the slab thickenings or foundations.

Framing overhanging foundations resulting in inadequate support to framing

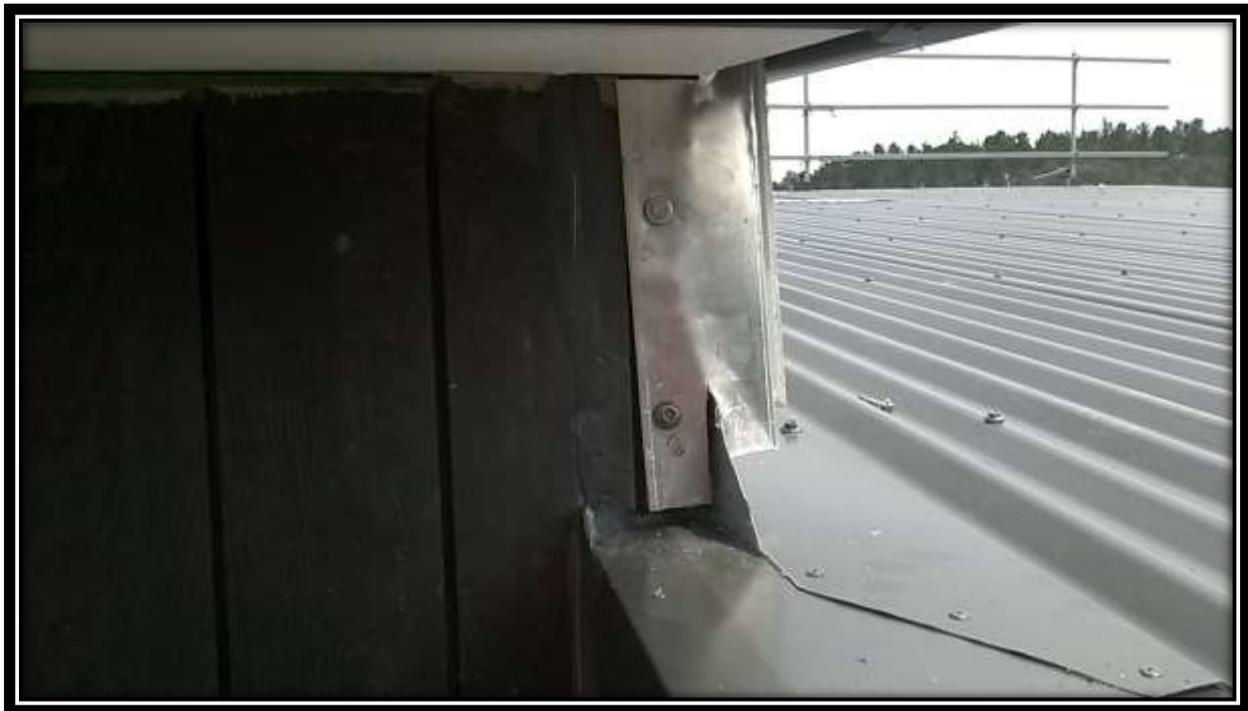
One of the biggest challenges faced by a number of builders is managing wall/fascia roof junctions. This is a critical cladding performance point requiring very good design and construction skills to ensure that there is no water ingress under any circumstances.

Poorly flashed roof junction
